Re: [FACILITY]

This Report will discuss the research, analysis, calculations, opinions, and conclusions of USA Management LLC. concerning the existing aquatic facilities at [FACILITY] Swimming Pool Facility located at [FACILITY ADDRESS].

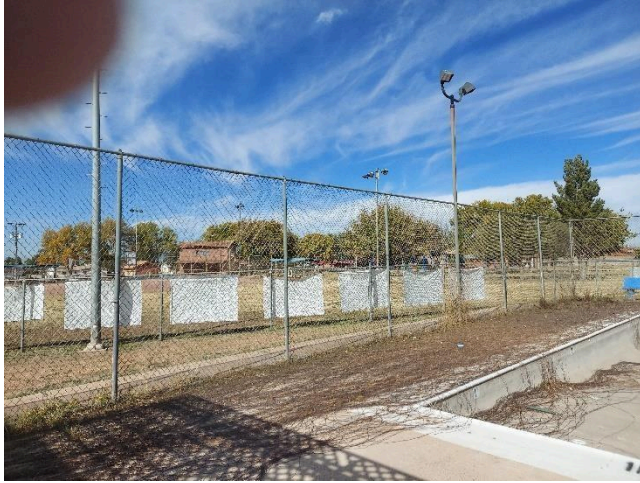
Chain link perimeter fence and exterior pole lighting.

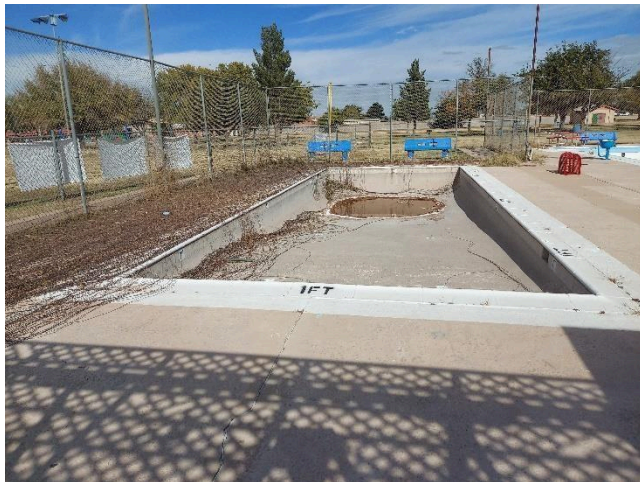
Wading pool.

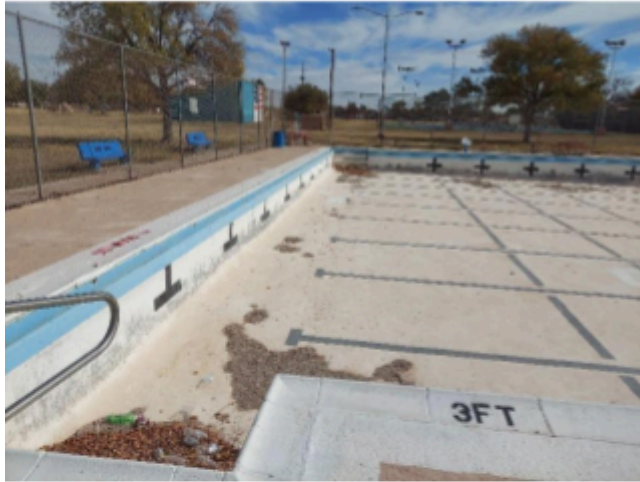
Lap pool – shallow end.

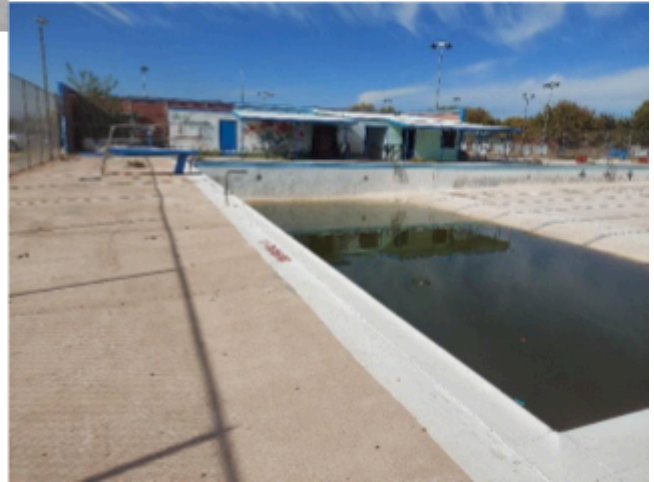
Lap pool – deep end with diving tower and springboard. Bath house and equipment yard with attached shade structures.

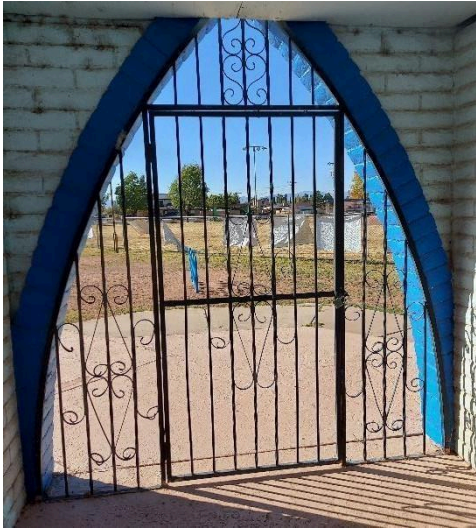
Entry gate at west side of bath house.

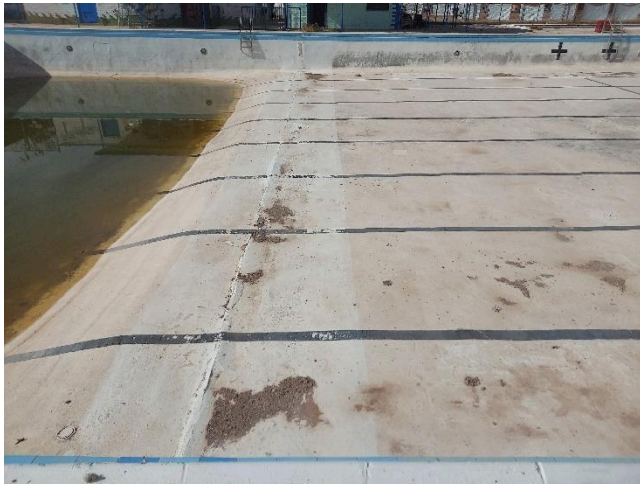
- (D) – The Lap Pool has numerous cracks in both the floor and walls. The Lap Pool expansion joint has failed and is no longer water tight.
- ARS R18-5-208

Lap pool expansion joint – failed caulk across entire joint.

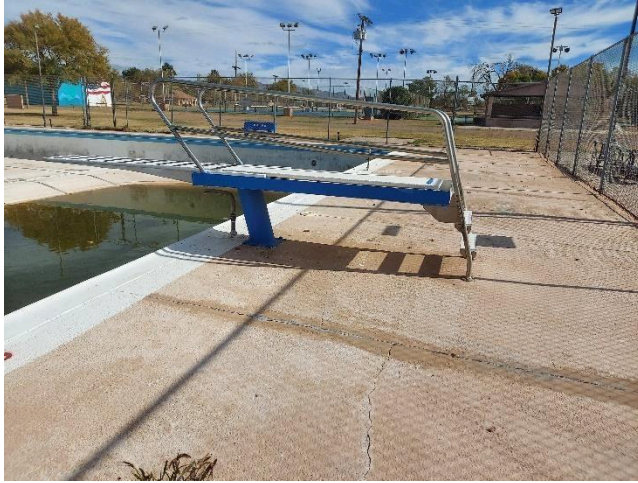
Significant cracks in deck. Minor corrosion on diving tower.

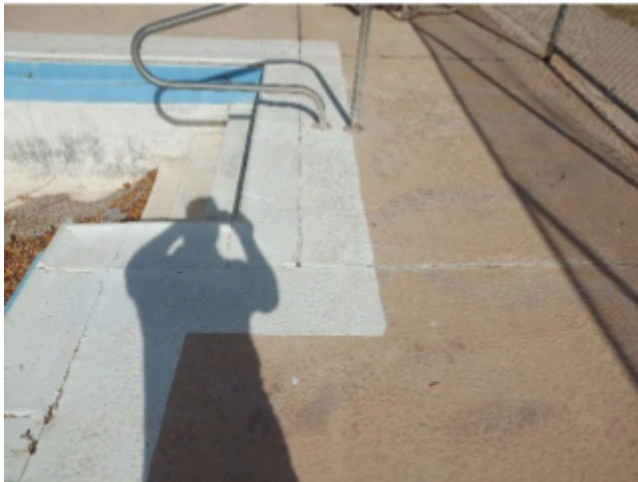
(J) Insufficient joints are in the pool deck to prevent cracking and movement. The width of some joints exceeds the allowable 3/16-IN. Construction and expansion joints in the deck are not watertight.

Separation between coping and deck.  
Failed caulk in joints.

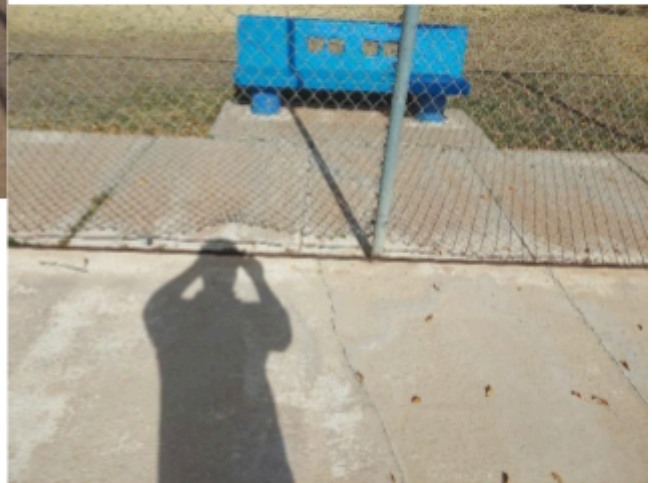
Bottom of fence tied and padlocked to rebar in an attempt to prevent unauthorized entry into pool area.

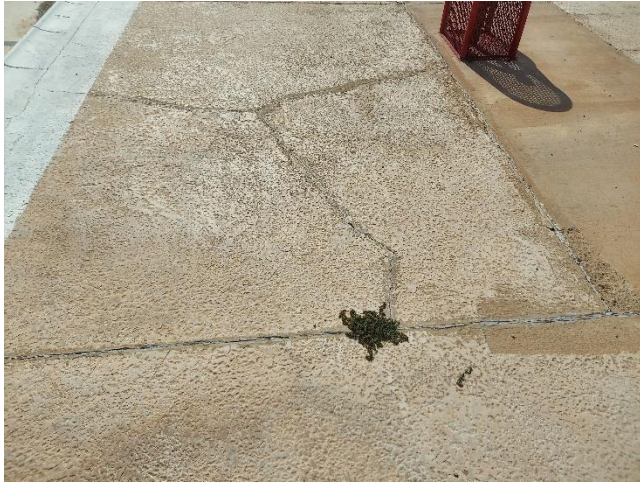
Significant cracks in deck with some separation. Failed caulk in joints.

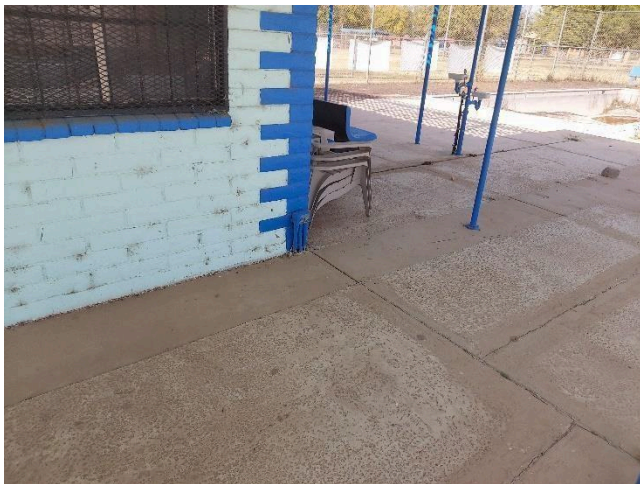
Electrical junction box – not elevated above pool water surface to comply with NEC.

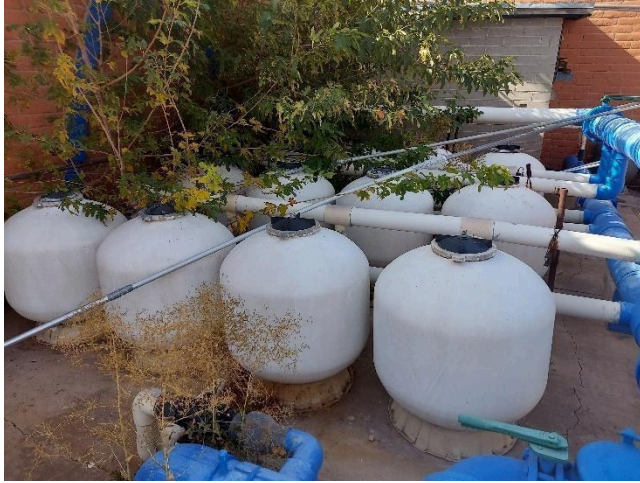
Lap pool filter plant – several filter tank lids are broken or missing, several filter base supports are broken.

Insufficient access to comply with OSHA.

Vegetation restricts sight and access.

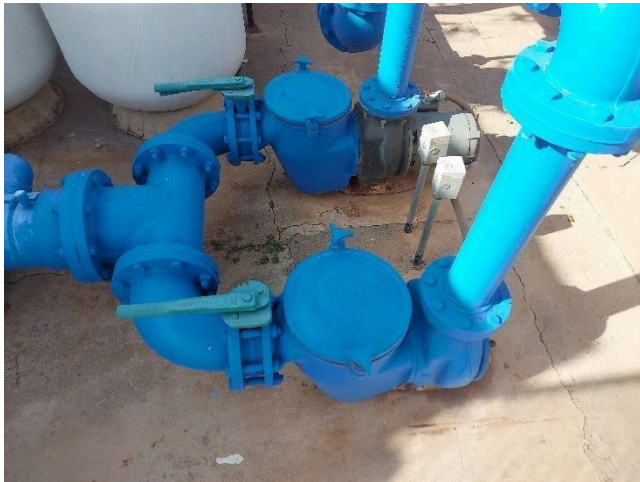
Lap pool filter pumps – one motor is missing, piping creates air blockages, pumps are not suitable for self-priming position.

No vacuum or pressure gauges.

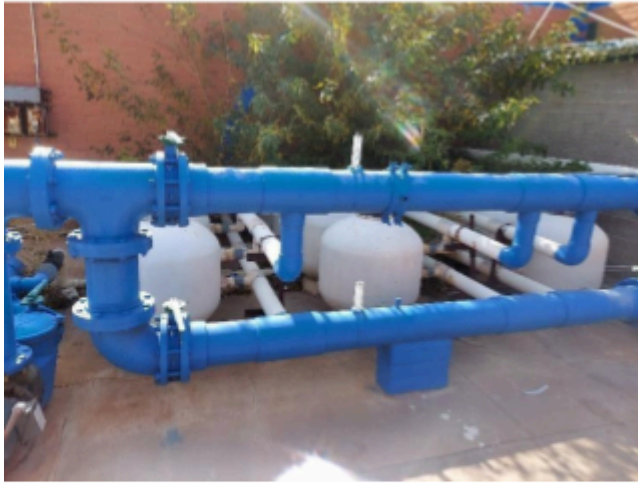
Lap pool filter plant manifold – no pipe supports on upper section, flow meters not located per manufacturers recommendations.

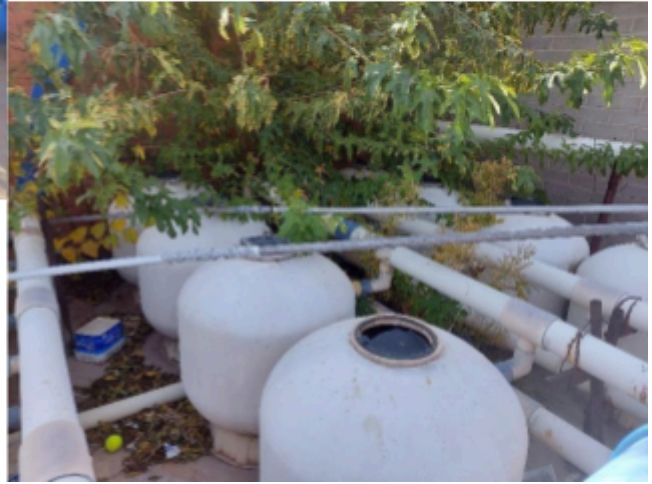
Lap pool filter plant – insufficient pipe supports on upper section, several filter tank lids are broken or missing, several filter base supports are broken.

Insufficient access to comply with OSHA.

Vegetation restricts sight and access.

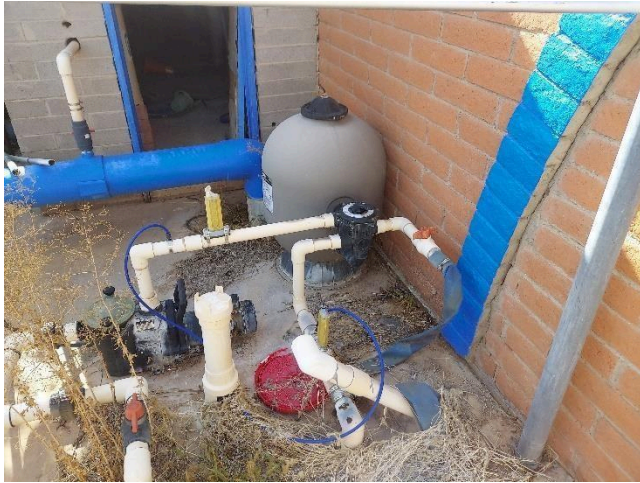
- (A) – Neither pool has an installed or portable vacuum system.
- ARS R18-5-236 – Disposal of Filter Backwash
  - (A) – It is not apparent if the backwash from the Lap Pool is directed into a sanitary sewer system. The filter backwash from the Wading Pool is directed onto the ground and not properly into a sanitary sewer system.

Wading pool filter plant – backwash does not tie into sanitary sewer, flow meters not located per manufacturers recommendations.

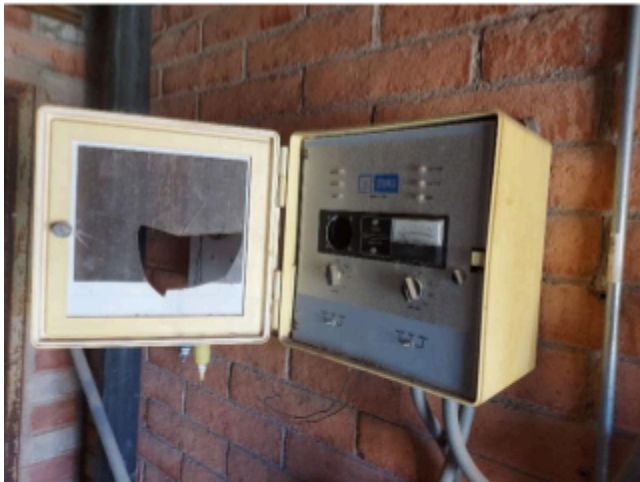
Lap pool chemical controller – significant damage to protective case and missing components.

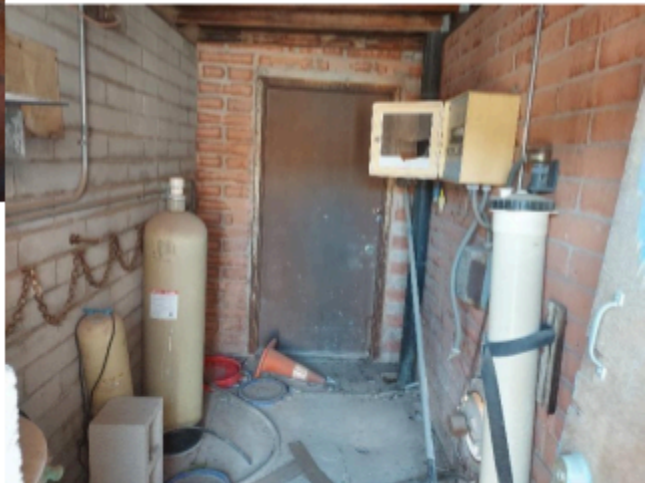
Storage room – debris and trash restricting access, inoperative equipment, electrical equipment does not have sufficient clearance to comply with NEC.

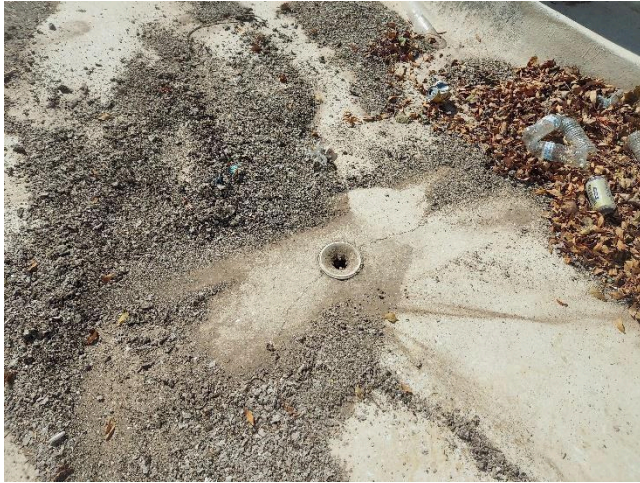
Lap pool floor return – missing cover plate.

Significant structural crack across pool floor.

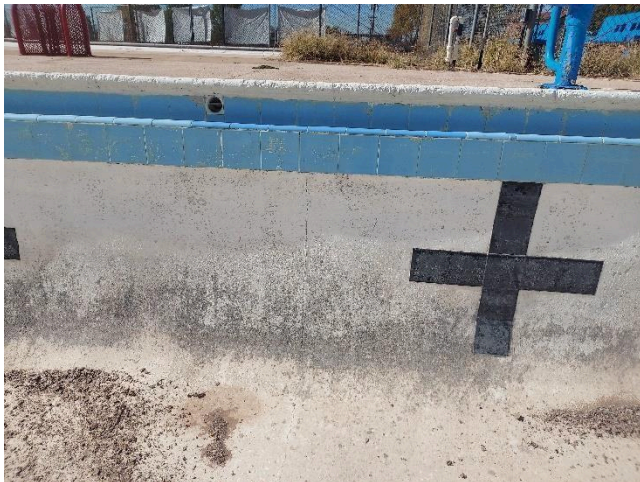
Significant structural crack in Lap pool wall translating through tile bands.

Tile and plaster spalling.

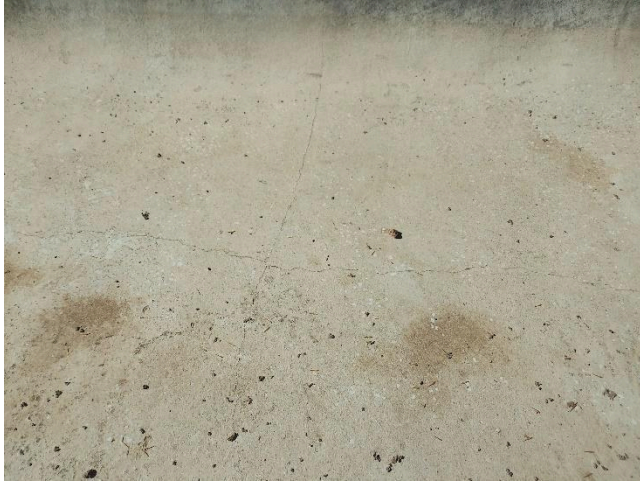
Significant cracks in Lap pool floor.

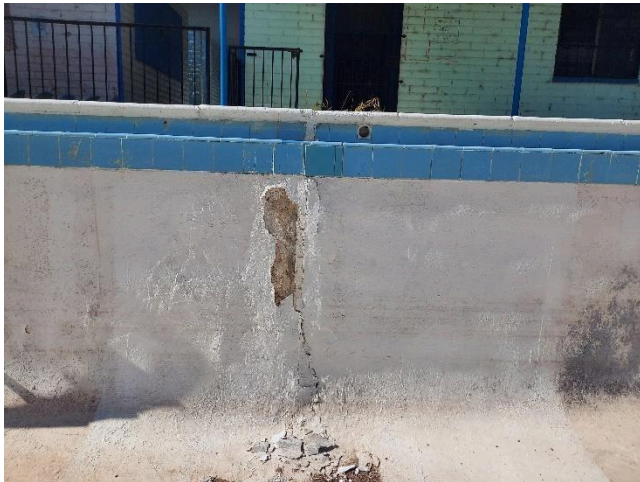
Lap pool expansion joint – significant structural failure, caulk and plaster failures.

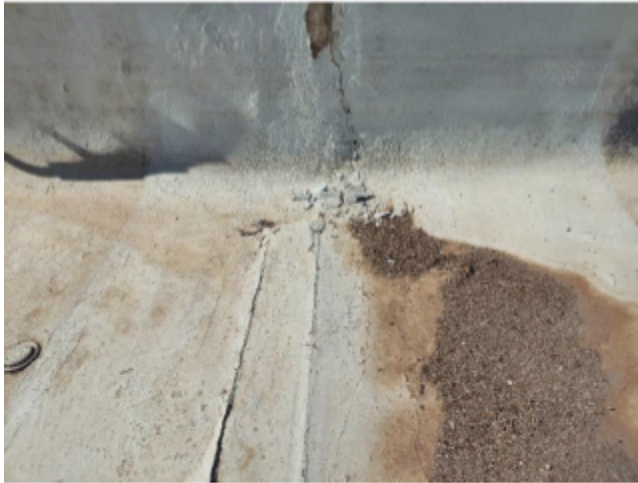
Significant structural crack in Lap pool wall translating through tile bands.

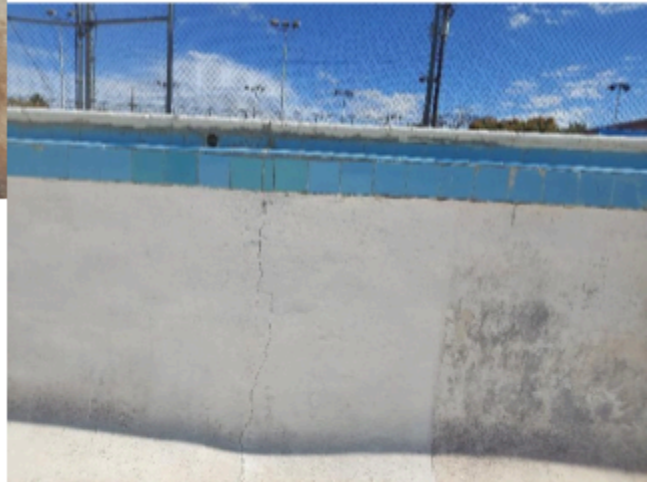
Lap pool expansion joint – significant structural failure, caulk and plaster failures.

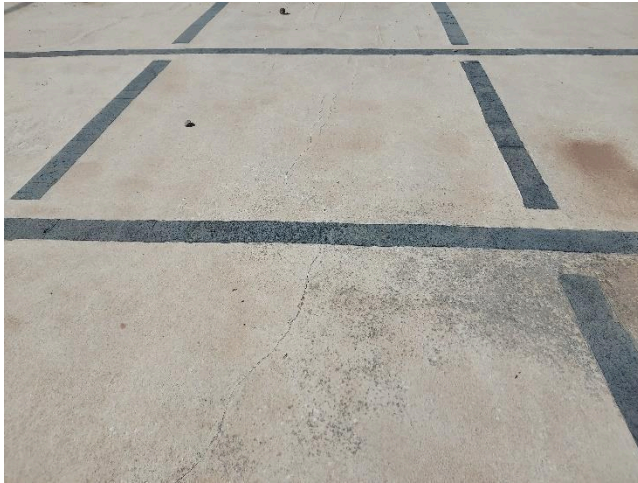
Lap pool floor – structural failure and separation with flexure cracks.

- The Lap Pool structure will require significant renovation work to seal the existing cracks and ensure there are no future structural failures. It is likely that any repair will be temporary and continued movement of the subgrade will cause new failures to appear over time. A permanent solution will require a completely new pool basin to be installed.
- The mechanical systems for both pools should be completely replaced to use current technology to create the highest water quality possible. This is the single most significant issue which affects the health of the pool users.
- Repair/replace the existing deck to ensure a watertight, slip resistant surface which has no trip hazards.
- Install compliant deck markers and safety signage.
- Renovate the dressing and sanitation facilities to meet the anticipated users and achieve minimum code compliance

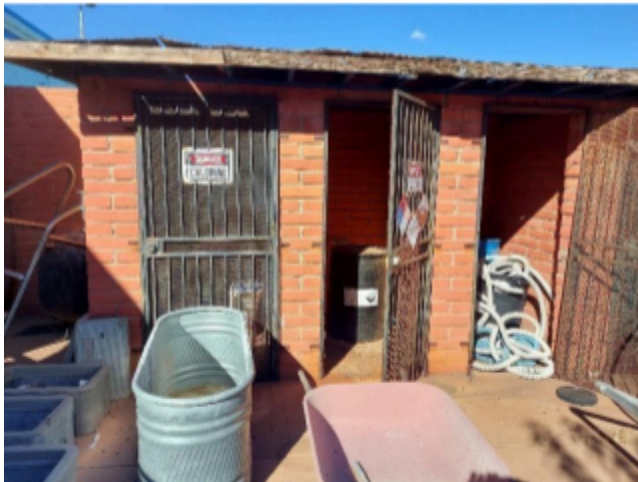
Chemical storage areas – rust and corrosion of metal surfaces. Dry rot in wood. Roof material has separated and no longer attached to support structure.

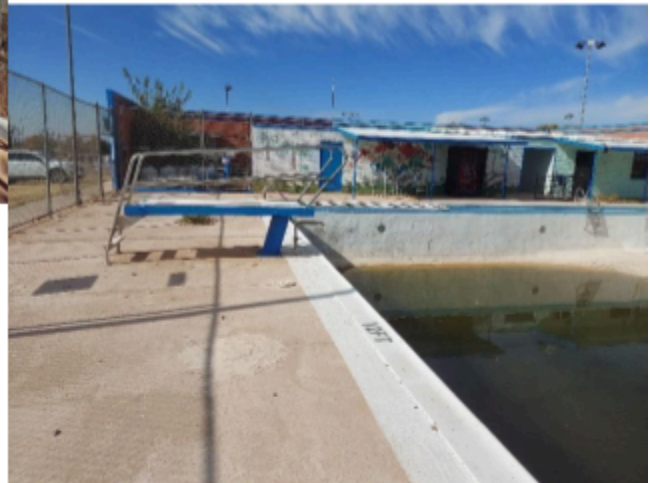
Lap pool – plaster spalling. Vertical displacement between deck and coping.

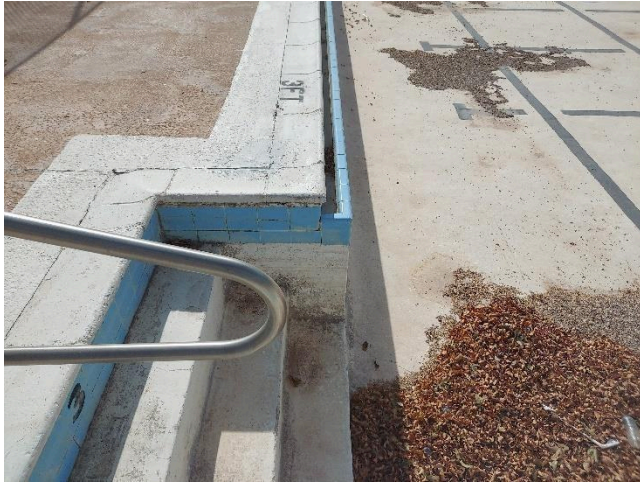
- (D) – The overflow collection system is not continuous around the pool perimeter. There is no surge chamber installed.
- ARS R18-5-233 – Vacuum System

Lap pool – gutter does not extend around entire pool perimeter.

Plaster and tile spalling.

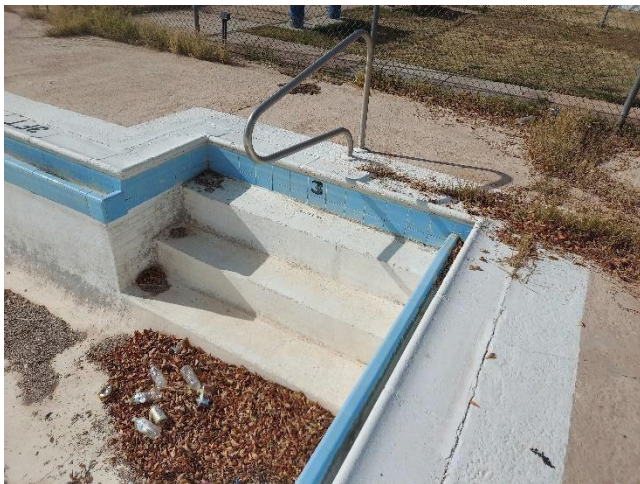
- (F) – The steps in the Lap Pool have riser heights which exceed the maximum allowable dimension of 12-IN.
- ARS R18-5-215 – Ladders
  - (A) – Due to width of Lap Pool exceeding 20-FT, ladders are required on each side of deep end.
- ARS R18-5-217 – Decks and Deck Equipment
  - (H) – Hose bibs are not located to allow access to all areas of the deck.

Lap pool – inconsistent step height, hand rail does not extend to bottom step.
